Inspection Report
Minerals Regulatory Program
Report Date: November 9, 2006

Mine Name: Hardaway
Operator Name: Ziegler Chemical and Mineral

Permit number: M0470072
Inspection Date: October 31, 2006
Time: 1:30-1:50 PM

M0470072, Hardaway Mine, Ziegler Chemical and Mineral

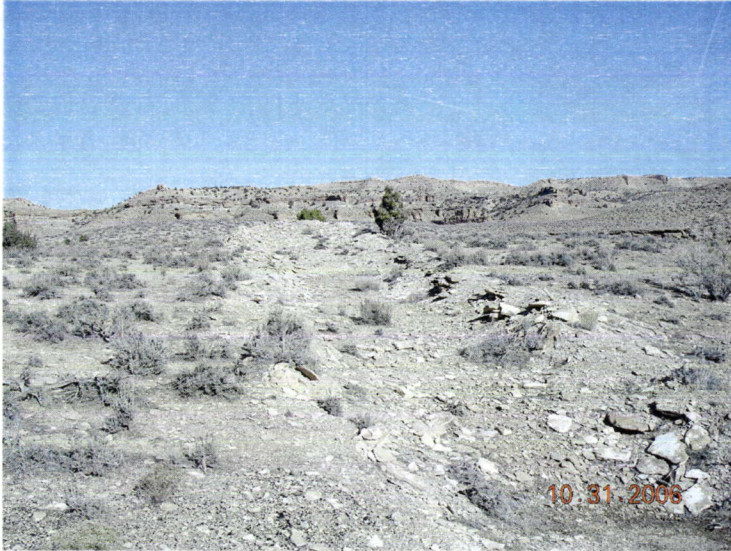
There are two trenches on the hill to the north of the mine (Photos 1 and 2), and there is also some waste Gilsonite (Photo 3). These areas do not appear to have been regraded.

The trenches are basically revegetated with volunteer vegetation.

Photo 1. One of the two trenches on the hill above the mine site.

I do not recommend that the trenches be regraded. The disturbances are small, and regrading would kill most of the established vegetation.

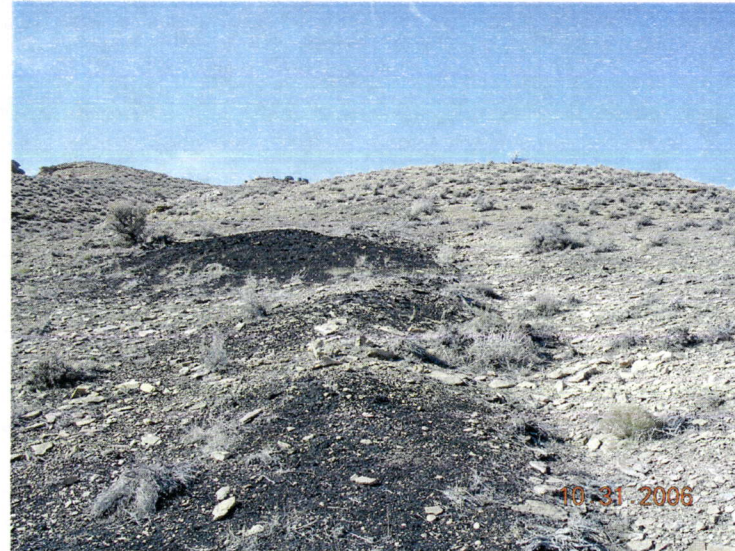
Photo 3. Waste Gilsonite on the hill above the mine.

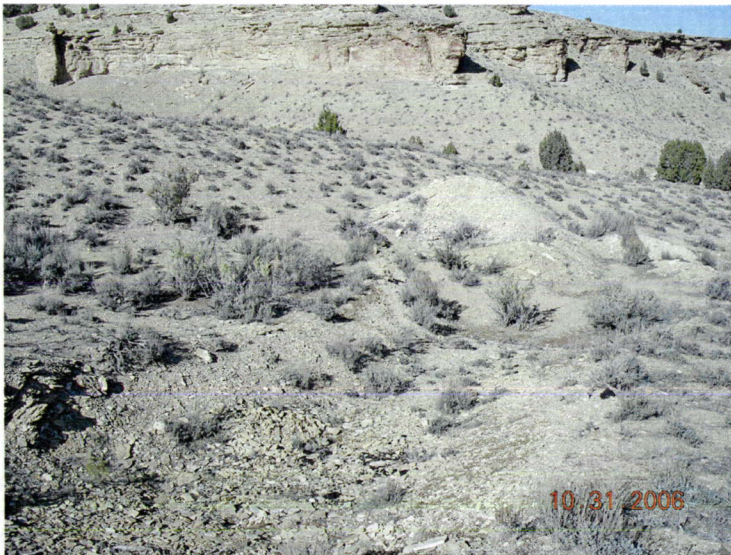
Photo 2. The other trench.

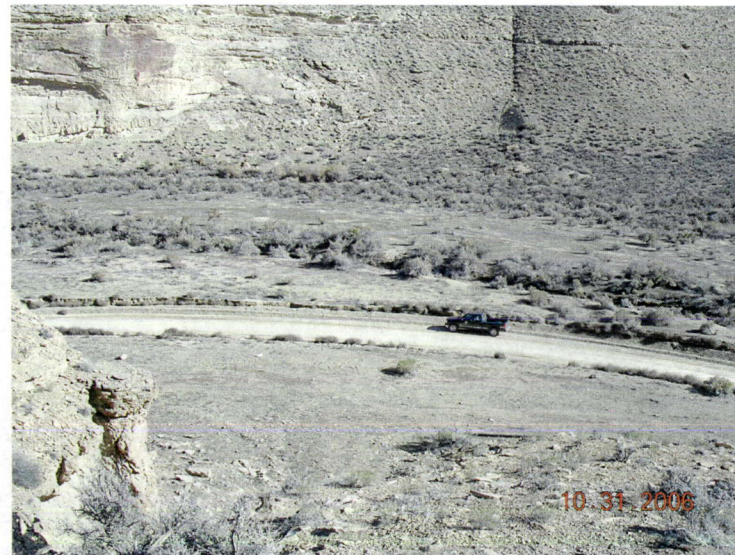
The mine site in the bottom of the canyon has essentially no desirable vegetation (Photo 4). While surrounding areas have a lot of cheatgrass and other weeds, they also have some native shrubs, particularly greasewood. I did not attempt to measure vegetation cover in any of these areas.

Photo 4. The mine site is below the road in this photo. Note the Gilsonite trench on the canyon wall.

I recommend that the operator make another attempt to revegetate the mine site. Right now would be a good time to do this: the area has had recent rain, so cheatgrass has probably germinated, and scarifying the surface would kill much of the cheatgrass and allow more perennial species to become established.
